# PCP FAILURE MODE

## OBSERVATIONS, CAUSES & SOLUTIONS

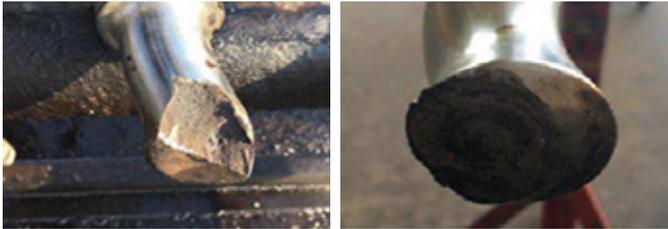
## › BROKEN ROTOR: TORSION

- Rough jagged surface throughout the majority of the rotor cross-section.
- No visible pattern is made.
- Generally broke in the first 2ft below rotor head or just below the rotor head.

- High amounts of torsional/bending stress put on the rotor (stick & slip effect at low speed, high deviation, high differential pressure)
- Solids entering the pump and blocked between rotor and stator.
- Too low space out: end part of rotor touching the tag bar and conducting to increase torque, up to rotor failure just below the head.
- Excessive swelling of the stator elastomer

- If stick and slip effect: increase speed (downsizing the pump) or upsize torsional stiffness (rod size increase)
- Optimize the pump setting depth by landing it at recommended DLS
- If high differential pressure: review PCM design to challenge PCP model selection
- If solid accumulation: limit quantity of start & stop, flush the pump regularly & systematically after a stop and before restart, optimize pump setting depth, as solid ratio at pump intake is directly linked to the pump position vs perforation
- If low space out: review space out calculation and on site proper realization

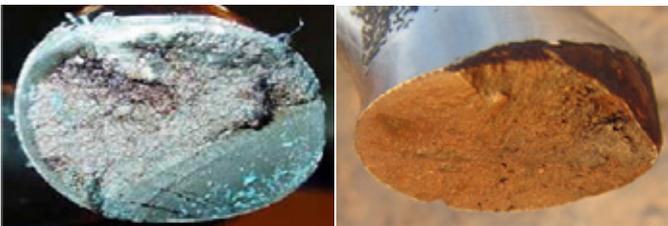
## › BROKEN ROTOR: FATIGUE

- Characterized by a flat, smooth surface across the majority of the cross sectional area of the rotor.
- A small section may be rough and jagged. Beach lines will be present.

Important and/or durable stress cycle (rotation and/or flexion) on the rotor possibly due to:

- operating rotor too far above stator (too high space out increase flexion)
- long run life at high speeds.
- landing pump in highly deviated section of well.
- a continuous torque and release of the pump (stick and slip effect).

- If high space out: review space out calculation and on site proper realization
- Reduce PCP speed (upsized the pump)
- Optimize pump setting depth by landing it at recommended DLS
- If stick and slip effect: increase speed (downsizing the pump), or upsize torsional stiffness (rod size increase)

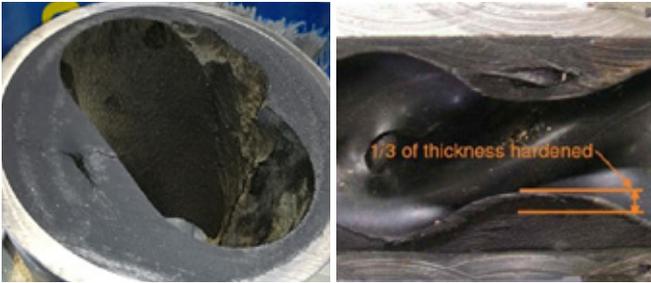
### HYSTERESIS

- The elastomer is brittle and hardened. (While performing a transversal cut, it is observed a hardening of the elastomer, generally @ 1/3 of the teeth.)
- Cracks in minor diameter (maximum elastomer thickness)
- Debonding can be observed.

Hysteresis is the result of energy accumulation due to insufficient heat dissipation. Heat accumulation conduct to over vulcanization that transform Nitrile elastomer to ebonite.

- Excessive pressure versus pump head or per cavities (improper internal pressure distribution)
- Excessive Swelling
- High temperature
- Improper rotor sizing
- Excessive speed

- If high differential pressure: review PCM design to challenge PCP model selection
- If excessive swelling: conduct a swelling test and adjust elastomer selection and rotor size if needed
- If high temperature: make sure that the elastomer is compatible with the downhole temperature and adjust rotor sizing
- If excessive speed: upsize pump model

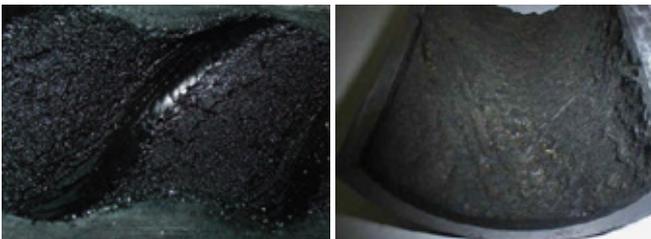
### DRY RUNNING

- Elastomer is rough and hardened on contact surface (orange skin).

- Not enough fluid to dissipate friction heat due to pump off condition or long gas slugs or fillage issue (viscous oil in small ID tail pipe) or plugged intake by solids

- Operate the pump at speed that warranty a minimum of fluid at intake (regular monitoring of fluid level)
- Ensure cavity filling by limiting flow restrictions at intake (increase ID of tail pipe, install top bushing)
- Set the pump deeper

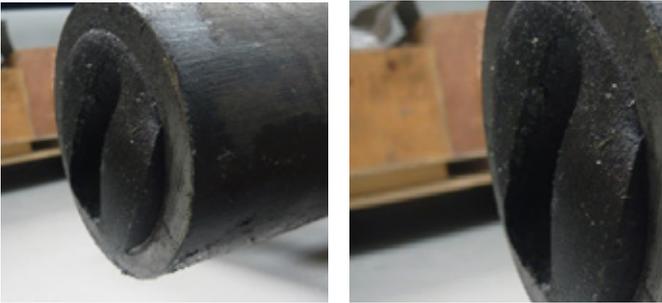
› SWELLING

- A smaller or deformed ID of the elastomer.
- Difficult to insert rotor into the stator (after flush or for a pump test).
- High torque and high efficiency recorded versus standard operation.
- Elastomer softening can be associated to swelling.

- Depending of elastomer, aromatics such as benzene, toluene ethylbenzene, and xylene may be the root cause of swelling.
- Chemicals use for various well treatment (acids jobs, paraffin inhibitor, light oil injection,...) may also generate elastomer swelling.

- Conduct compatibility test to select the best elastomer
- If swelling is within acceptable range, adjust rotor sizing (smaller)
- If chemical treatment is needed, check compatibility with elastomer

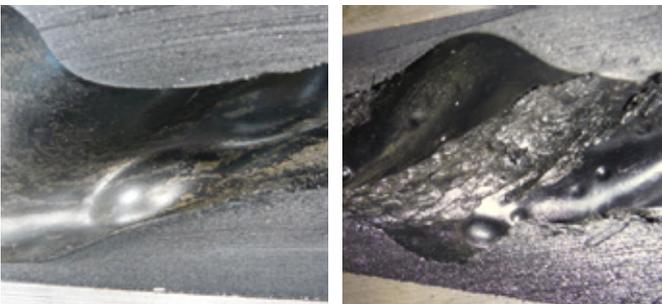
› BLISTERS

- Blisters (gas pockets) or burst blisters into elastomer
- Referred as "Explosive decompression" or "Rapid Gas decompression".

- Blistering appears when a fluid is either liquid, either gas depending on pressure and temperature conditions.
- Fluid is entering into elastomer as liquid phase. When pressure drops (Pump stop or pull out) the liquid becomes gas and cannot escape quick enough from elastomer. This conduct to blister.
- Generally quick phenomena as soon as pressure drops but sometimes it can appear weeks after pump pull out

- Before stop, decrease pump discharge pressure progressively
- Select adapted elastomer

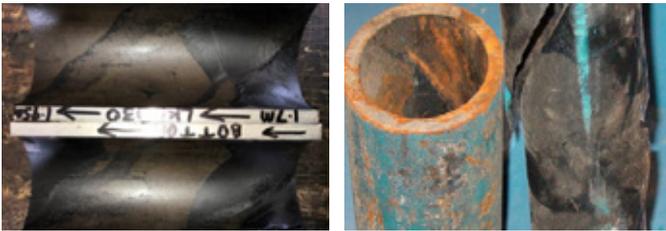
DEBONDED ELASTOMER

- Torn elastomer in long intact pieces
- The inner steel wall is clean of any elastomer (bond failure between stator housing and glue)
- The inner steel wall is cover by a thin black layer of elastomer (bond failure between glue and elastomer)
- The inner steel wall is cover by a black layer of elastomer (elastomer failure, such failure mode should not be considered as debonding)
- Usually associated with short run life

- Extreme heat in the pump.
- Chemical attack.
- Manufacturing defect (wrong metal housing rugosity, poor surface cleaning before glue application, wrong uniformity and thickness of glue layer)

- Adapt elastomer and glue selection to downhole temperature
- Check chemicals compatibility with elastomer & glue

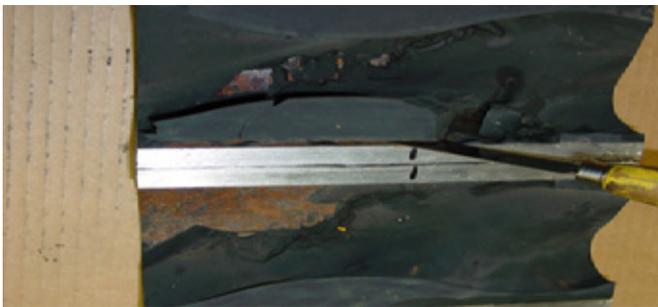
MISSING ELASTOMER (TORN)

- Large pieces of elastomer missing from the stator.
- "High pressure jetting" marks are sometime associated

- Excessive elastomer stress due to:
  - Exceeding pressure rating of pump (mainly at discharge)
  - Solids traveling through the pump (bottom of stator)
  - Pump Off (+hard elastomer)
- Manufacturing defect (stator elements synchronization issue or elastomer injection process).

- If high differential pressure: review PCM design to challenge PCP model selection
- If solids : install a perforated tail joint at the intake
- If pump off issue:
  - Operate pump at speed that warranty a minimum of fluid at intake (regular monitoring of fluid level)
  - Ensure cavity filling by limiting flow restrictions at intake (increase ID of tail pipe, install top bushing)
  - Set the pump deeper

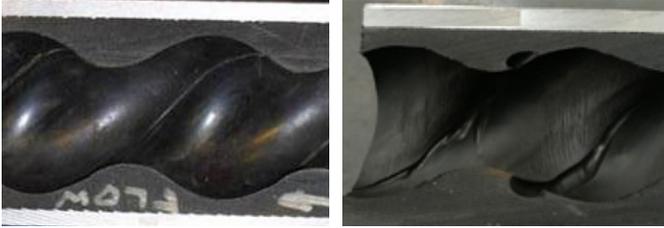
» HIGH PRESSURE JETTING

- Worm-like grooves cut in the direction opposite to the flow

- High pressure fluid slipping (backflow) within the pump.
- Over-pressuring of the pump.
- Pump with low efficiency usually combined with low fluid viscosity.

- If high differential pressure: review PCM design to challenge PCP model selection
- Limit the internal leakage by rotor and/or pump geometry selection

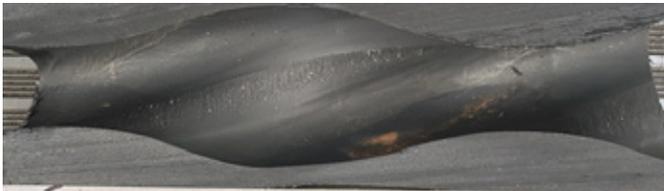
» STATOR ABRASION

- Score marks along the contact surfaces
- Marks are typically perpendicular to the length of the stator

- Solids traveling through the pump (sand, iron pyrite, casing cement, coal, etc.)
- High speeds will increase severity of damage

- Select soft elastomer and tight stator/rotor fit
- Select adapted PCP geometry that facilitate pushing vs crushing of solids

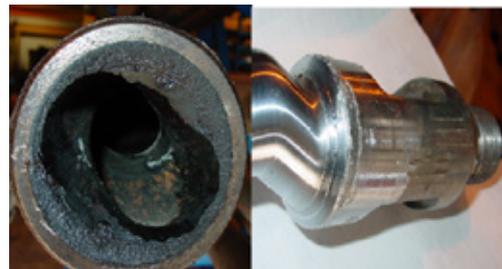
» ROTOR HEAD RUNNING IN STATOR

- Wear on the rotor head will be visible.
- The top of the stator will be damaged.
- Tag bar could be also damaged.

- Usually caused by improper space-out.

- Review space out calculation and on site proper realization

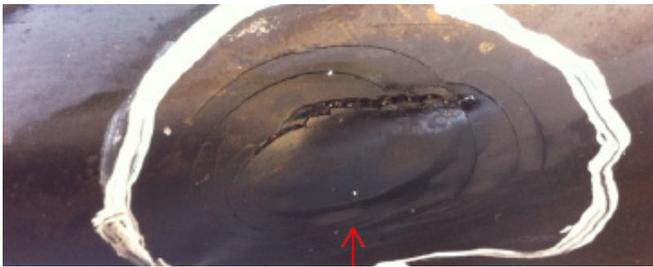
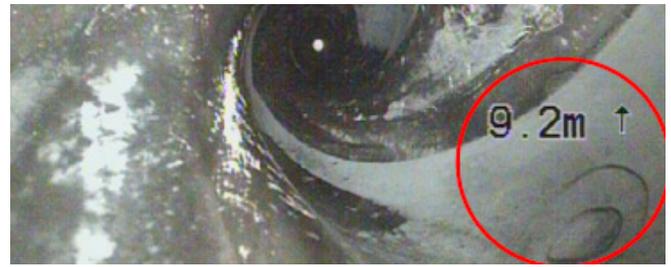
### FOREIGN ELEMENT

- Deformed parts of the profile (bump)
- Cracks or broken parts of the profile
- Generally associated with parted rods due to sudden torque increase

- Solids traveling through the pump (sand, iron pyrite, casing cement, coal, etc.)

- Install a perforated tail joint at intake

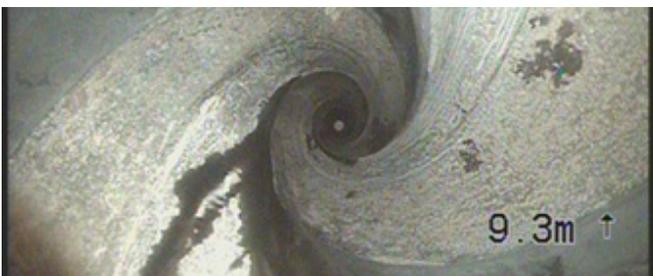
### WEARING

- General wear along the profile
- Generally associated with low efficiency & wear on the rotor

- Solids traveling through the pump (sand, iron pyrite, casing cement, coal, etc.)
- Low lubrication (high water cut)

- Install a perforated tail joint at intake
