## › PCP ROD STRING FATIGUE

3/24/2022

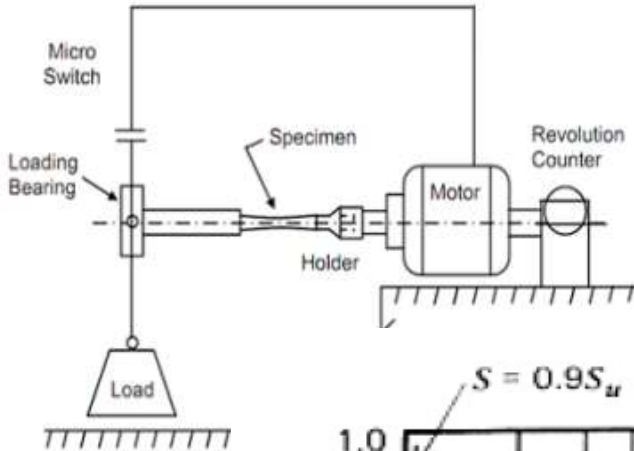
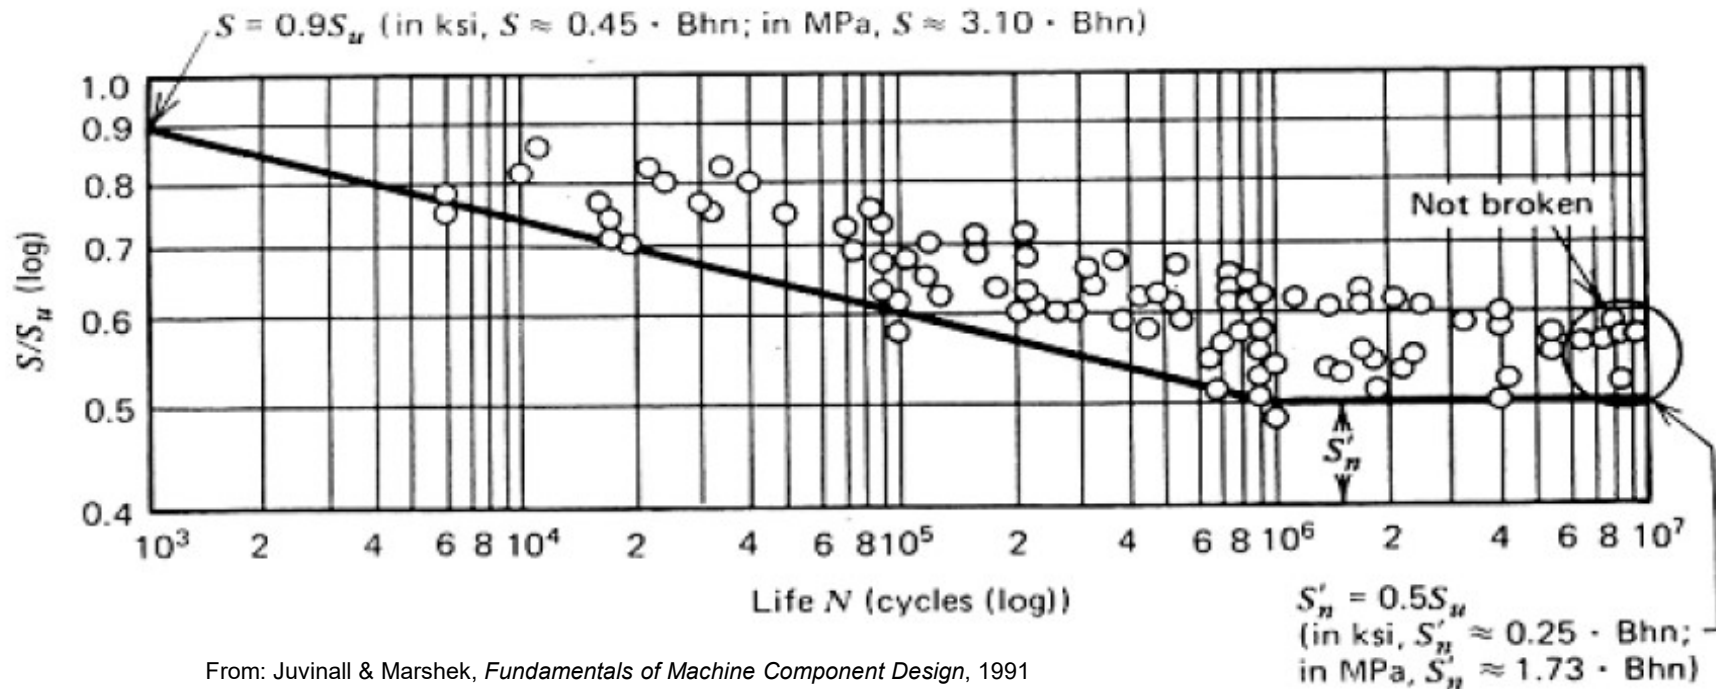
## › FATIGUE IS RANDOM

We cannot predict when a fatigue failure will happen – only the earliest time when it might happen

From: Juvinall & Marshek, *Fundamentals of Machine Component Design*, 1991

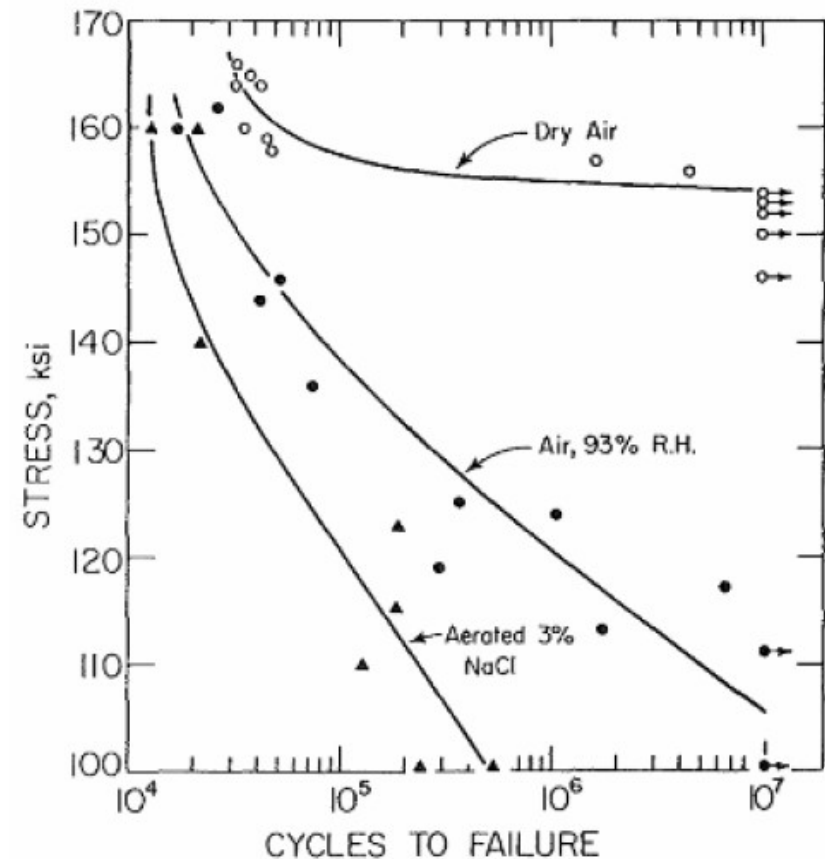
## › CORROSION

- **This is a set of S-N curves**

S=stress, N=number of cycles

- **There is 0 mean stress, the stress shown is fully alternating**

- **In dry air (no corrosion), this steel may not have a fatigue failure at all if the stress is under 155 ksi**

Called the “endurance limit”

- **In more corrosive environments, the life is significantly reduced and there is no endurance limit**

From: McEvily, *Atlas of Stress-Corrosion Fatigue Curves*, 1990

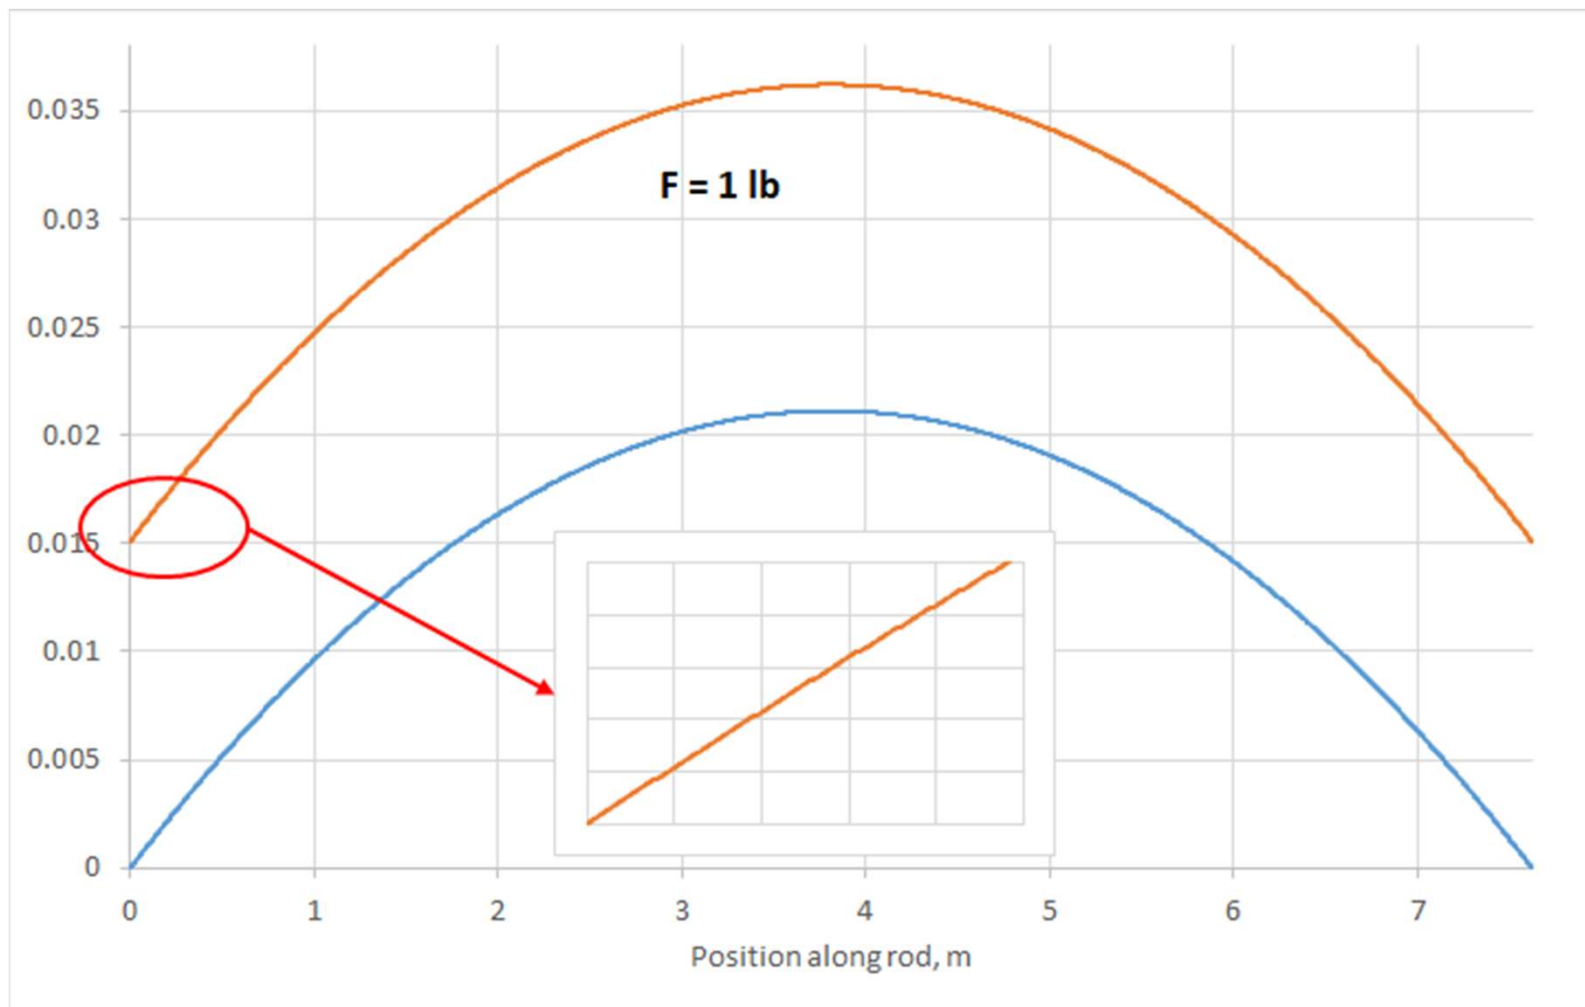
## › EFFECT OF ROD TENSION

- **However, the wellbore DLS is not evenly distributed along the rod—we need to know the maximum curvature in the rod**
- **Curvature is concentrated near the connections**

Example: 1" rods, full size couplings, 5°/30m DLS, 20000 N tension: effective curvature is > 30°/30m

- **Effective curvature increases as:**

Tension increases

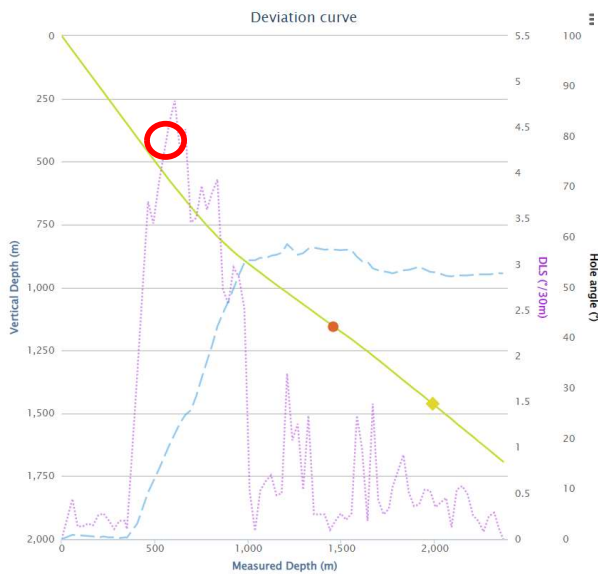
Failure Analysis FA202000369

- PCM Failure Analysis website
- Rod failure was near to highest DLS in the well

Rank	System item	System observation	Comments
Rank 1 (most relevant)	Rod - Body	Broken/Fractured	Parted 73rd sucker rod (on body) due to fatigue failure
Rank 2 (less relevant)	Torque Anchor	Broken/Fractured	Broken (missing) 4 anchoring blades

General comments: Parted sucker rod N°73. Missing anchoring blades on torque anchor.

- Difficulties to POOH Rod String
- Parted Rod String
  - Distance from surface: 560 m or ft
- Rod Centralizer Above Pony Rod
  - Material: Plastic Size: 3 1/2 - 1"
- Pony Rod Above Rotor
  - Length: 8 ft Diameter: 1 1/8"
- Tubing String Leak
  - Torque Anchor Spring Test at Surface Conducted
  - Test result: Not ok

File #VISY3  
Distance from top: 560 m or ft  
Description: Parted rod  
Comments:

File #VISY4  
Distance from top: 560 m or ft  
Description: Observed fatigue failure on rod  
Comments:
